FINAL REPORT

DC - 10

HL 7328

KOREAN AIR MCDONNELL DOUGLAS DC-10-30 KOREAN REGISTRATION
NL-7328 CRASHED NEARBY TRIPOLI INTERNATIONAL AIRPORT SOUTH
-EAST OF RUNWAY 27 ON JULY 27TH 1989.

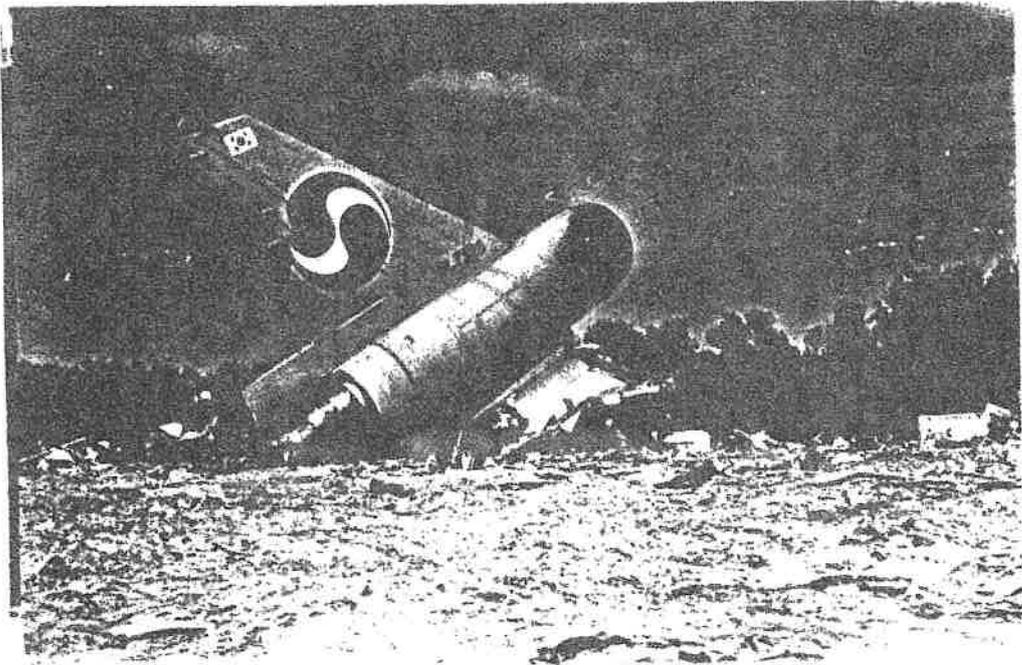
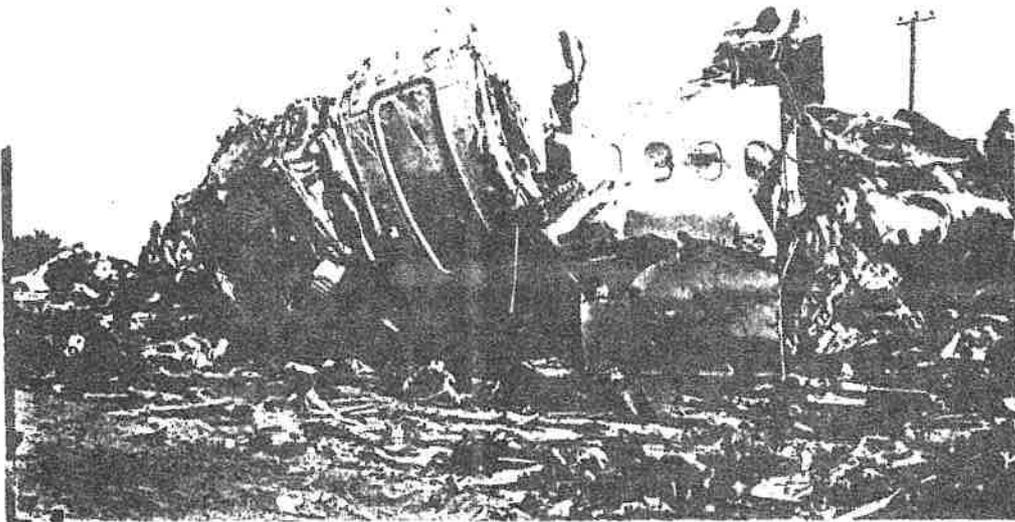
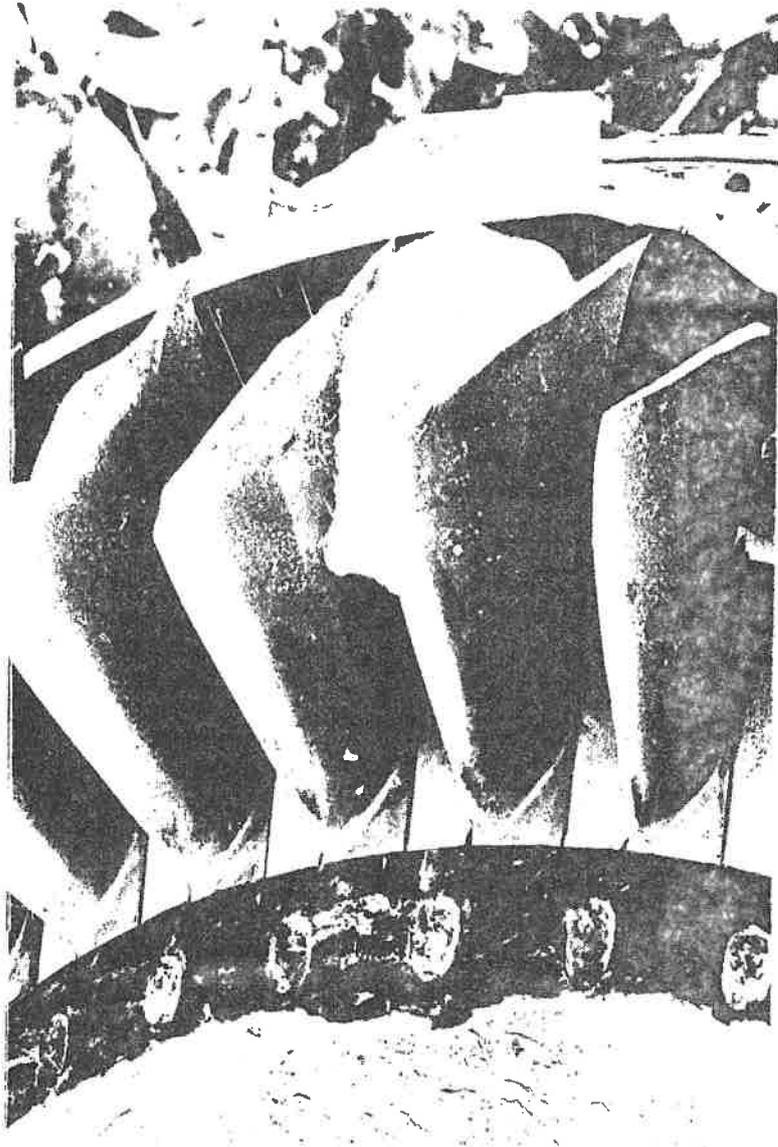
SELECTED PHOTOS FOR A/C WRECKAGE

The main wreckage shows the aircraft has disintegrated. The centre part of the fuselage turned over about 50° , and the forward fuselage with the cockpit upside down and heading South-East. The left wing was broken into two pieces and separated from the centre box, but was not damaged by fire. The right wing separated from center-box and was completely destroyed by fire. The fuselage was also destroyed by fire except for about 10m of the forward part including the cockpit. The empanage and engine number two were in one piece and only part of the lower cowling was damaged by the fire. The tail was pointing to the North-West. The right hand main and nose landing gears were found with the main wreckage. The right hand wheels separated from the strut. The nose landing gear was a complete unit but detached from the aircraft.

Engine No. 1 was lying with the top "12 O'Clock" position on the ground. Fan blades, disc and 2-4 stages of the low pressure compressor, the forward and aft fan case separated from the main engine. All blades bent or broken. The forward mount bolt sheared, the left hand forward lug of the rear mount was broken and missing. Right hand lugs are intact with bolt in place. Cowlings, reversers, and tailpipe all separated. Lube and scavage pump not located. Guidance of heavy rub marks on the spool of the H.P.C. sand dirt and small pebbles in the L.P.T. Turbine blades from 10 O'Clock position to 1-30 position broken and bent. No evidence of fire or uncontained failure.

Engine No.3: The fan forward casing missing probably burried with the rubble of the stone was found near the engine. The fan aft casing and frame separated to the fan frame and compressor front case, locating pin still in place. 24 blades were broken above platform. 7 blades bent in the direction of rotation, and 7 more in the opposite direction. A large stone was impeded between two fan blades. The aft rotor attached to the LPT shaft. No damage to the HPC casing.

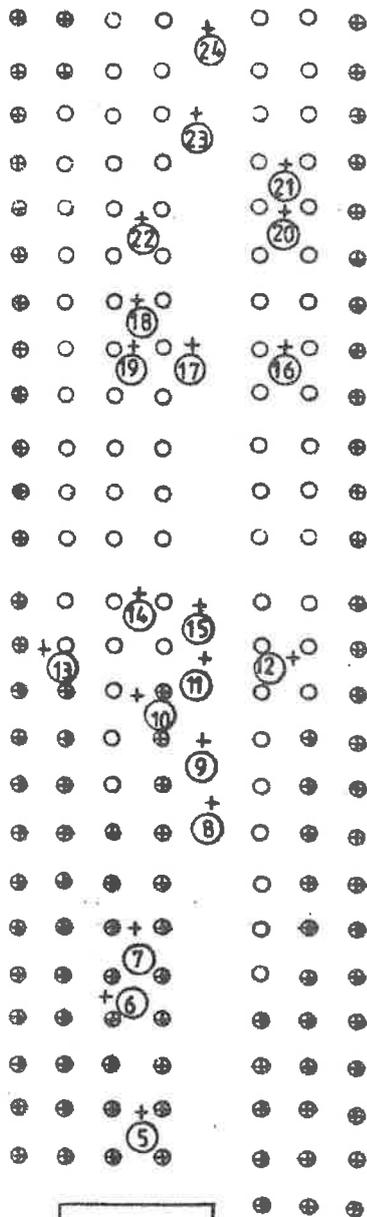
- 1- First Impact & Left Landing Gear Wheel
- 2- Left L/G Strut on Roof.
- 3- Impact of Centre Gear and Centre L/G.
- 4- Impact of Left Hand Trailing Edge Flap and No 1 engine transfer gear box. part of the flap, main gear box engine control.

- 5- Part of flap
- 6- Outboard left aileron
- 7- Engine cowling (inlet lip)
- 8- Lower part of tail cone .
- 9- Upper " " " " .
- 10- Left engine pylon
- 11- Control Quadrant .
